TAMU Project

**Energy Consumption Data Quality Assurance/Quality
Control Assessment Report for the
Month of July 2016**

**Utility & Energy Services
Division of Administration
Texas A&M University**

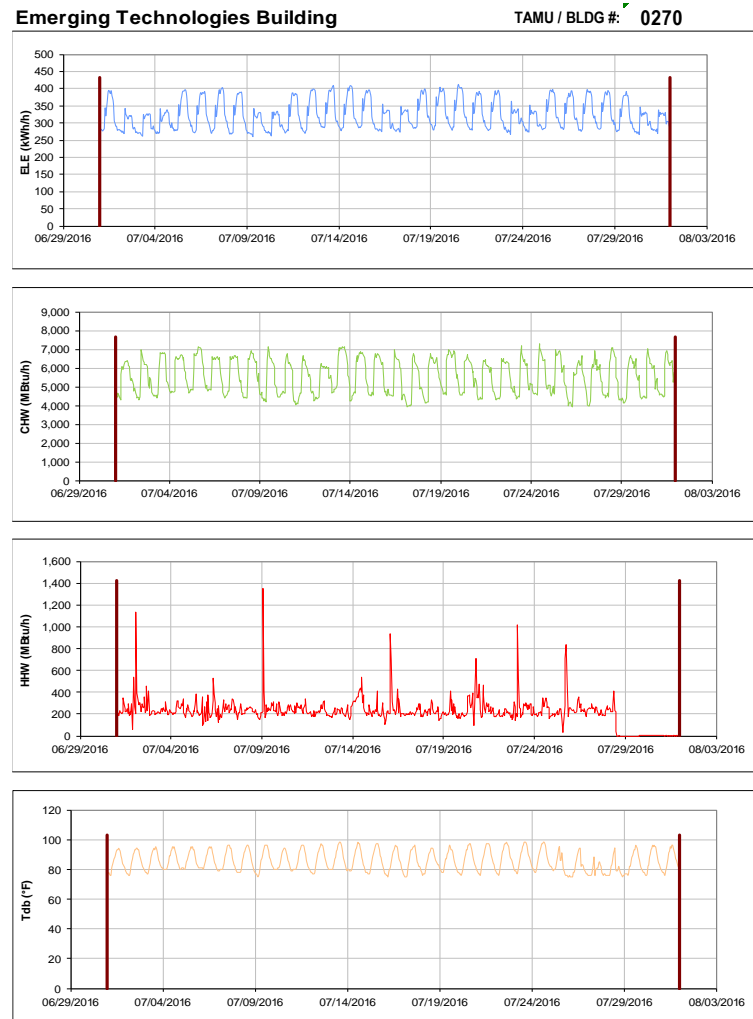
Figure III-1 Hourly Whole Building Electricity, Chilled Water, and Hot Water Consumption for Emerging Technologies Building during the Month of July 2016 and the Corresponding Hourly Outdoor Dry Bulb Temperature for College Station, TX

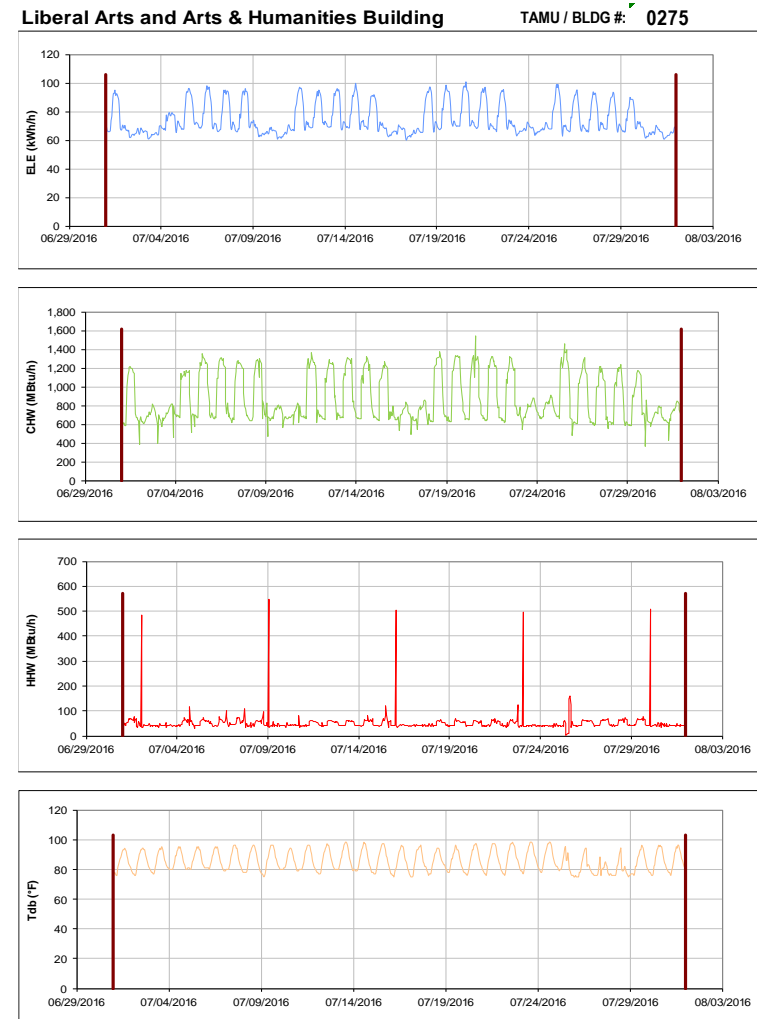
Figure III-2 Hourly Whole Building Electricity, Chilled Water, and Hot Water Consumption for Liberal Arts and Arts & Humanities Building during the Month of July 2016 and the Corresponding Hourly Outdoor Dry Bulb Temperature for College Station, TX

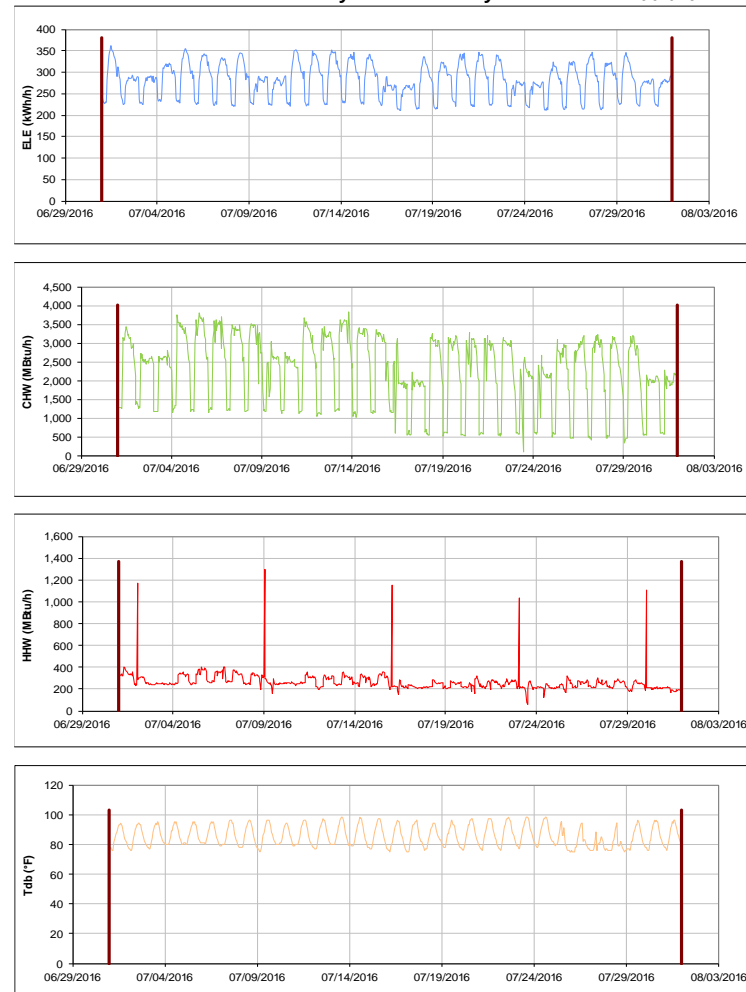
Mitchell Inst. for Fundamental Phys & Astronomy TAMU / BLDG #: 296-0297

Figure III-8 Hourly Whole Building Electricity, Chilled Water, and Hot Water Consumption for Mitchell Inst. for Fundamental Phys & Astronomy during the Month of July 2016 and the Corresponding Hourly Outdoor Dry Bulb Temperature for College Station, TX

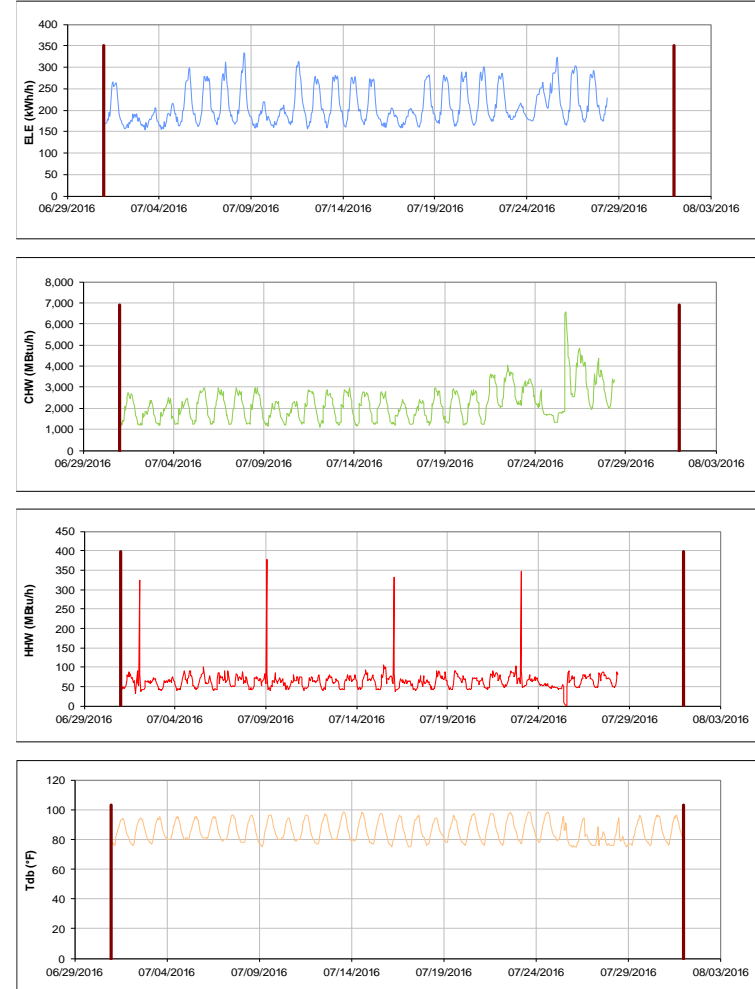
TAMU / BLDG #: 0353

Figure III-10 Hourly Whole Building Electricity, Chilled Water, and Hot Water Consumption for Bright Aerospace Building during the Month of July 2016 and the Corresponding Hourly Outdoor Dry Bulb Temperature for College Station, TX

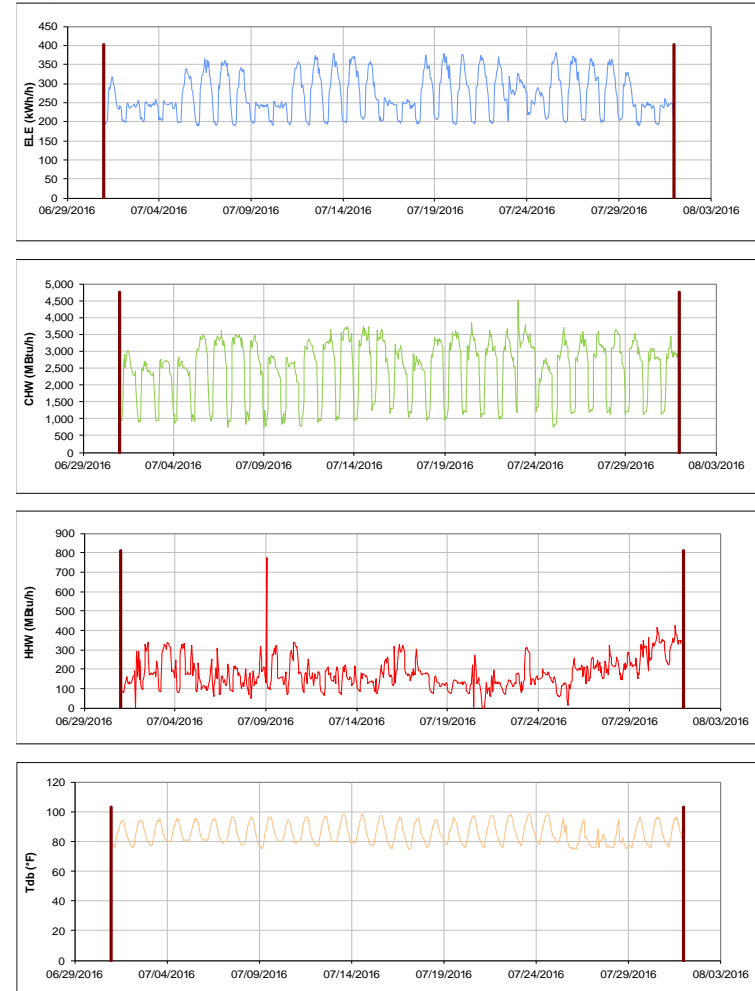
TAMU / BLDG #: 0361

Figure III-14 Hourly Whole Building Electricity, Chilled Water, and Hot Water Consumption for Bright Football Complex during the Month of July 2016 and the Corresponding Hourly Outdoor Dry Bulb Temperature for College Station, TX

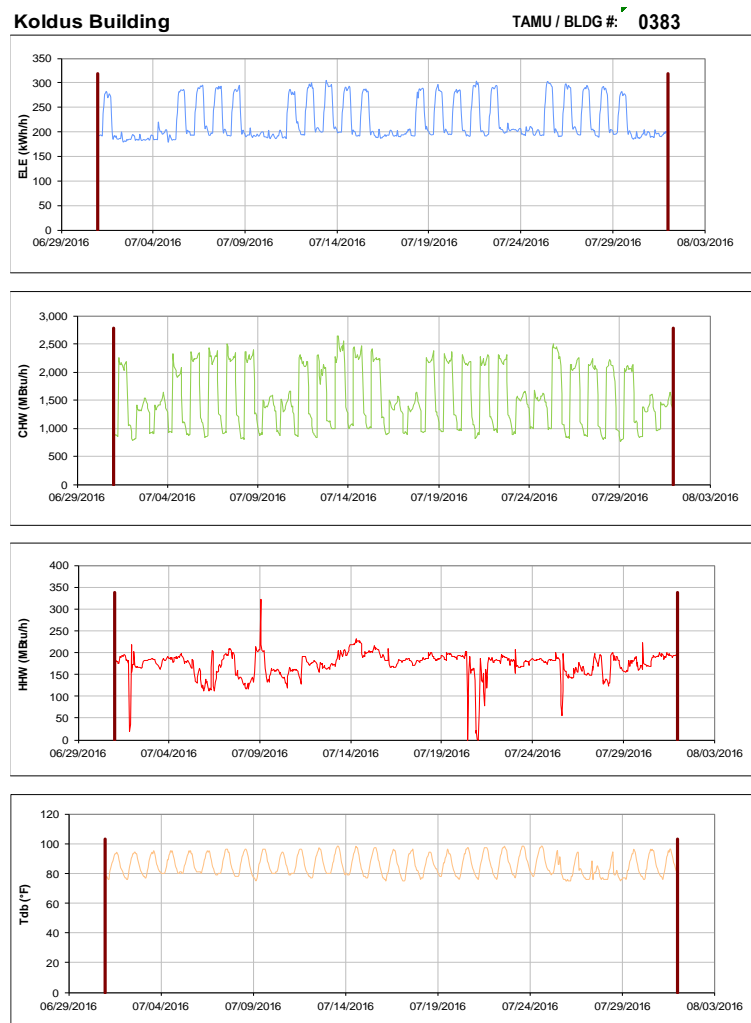
Figure III-17 Hourly Whole Building Electricity, Chilled Water, and Hot Water Consumption for Koldus Building during the Month of July 2016 and the Corresponding Hourly Outdoor Dry Bulb Temperature for College Station, TX

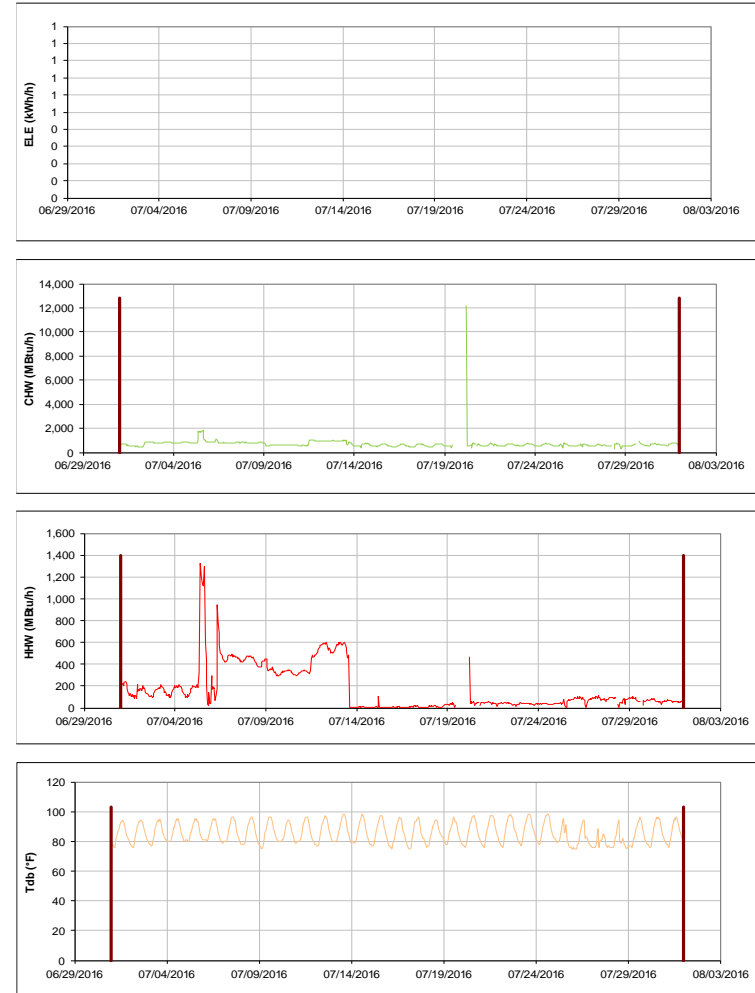
TAMU / BLDG #: 0403

Figure III-28 Hourly Whole Building Electricity, Chilled Water, and Hot Water Consumption for Fountain Hall Dorm 4 during the Month of July 2016 and the Corresponding Hourly Outdoor Dry Bulb Temperature for College Station, TX

The CHW and HHW consumption for #401 Kiest Hall were mostly in the range of 300-700 Btu/day/ft² and 80-600 Btu/day/ft², respectively. If CHW/HHW meters (MID 009151 and 009152) covered #1404 Plank LLC, #401 Kiest Hall and #403 Fountain Hall, the consumption levels would be around 200-400 Btu/day/ft² for CHW and 40-300 Btu/day/ft² for HHW. It is recommended to check which buildings were covered by MID 009151 and 009152.

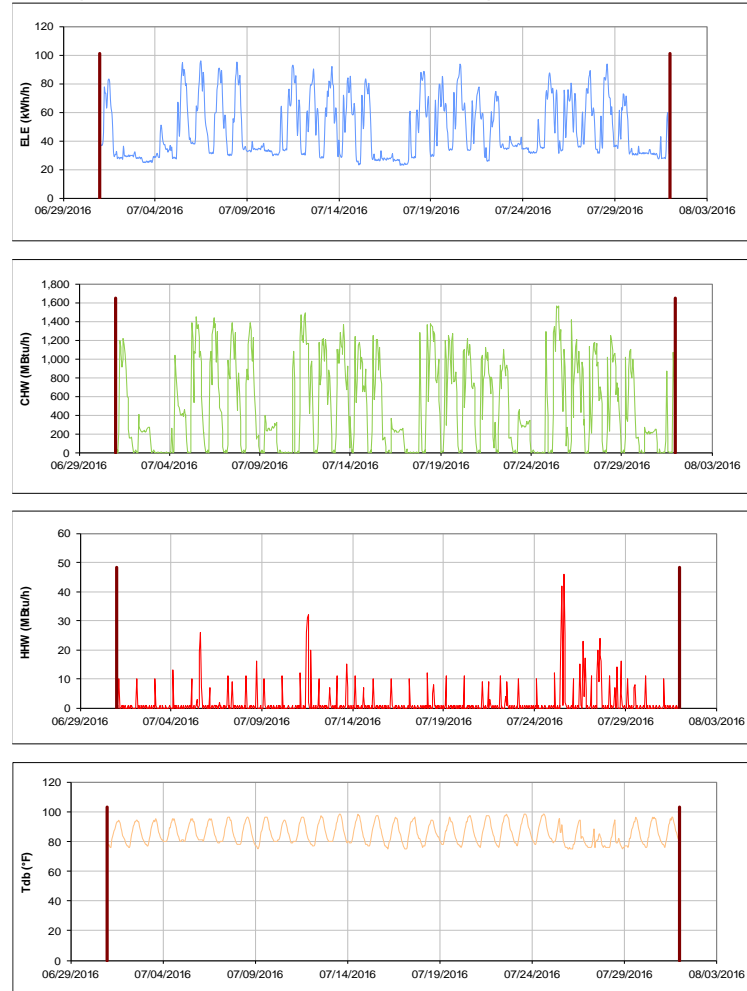
Harrington Education Center Classroom Building TAMU / BLDG #: 0438

Figure III-51 Hourly Whole Building Electricity, Chilled Water, and Hot Water Consumption for Harrington Education Center Classroom Building during the Month of July 2016 and the Corresponding Hourly Outdoor Dry Bulb Temperature for College Station, TX

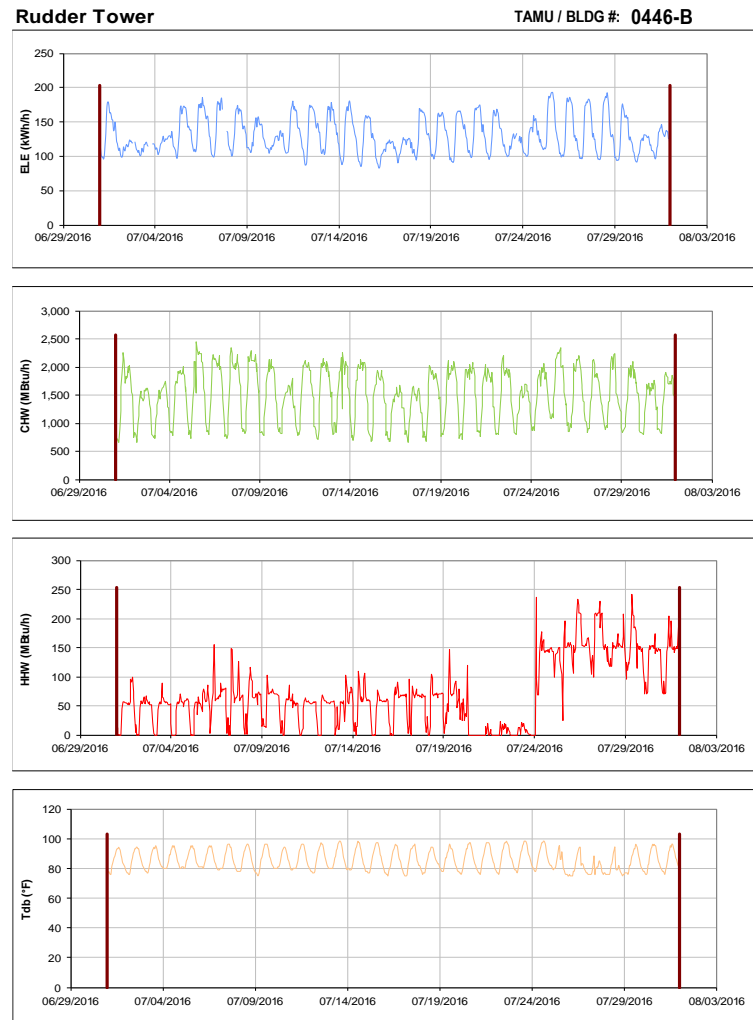
Figure III-61 Hourly Whole Building Electricity, Chilled Water, and Hot Water Consumption for Rudder Tower during the Month of July 2016 and the Corresponding Hourly Outdoor Dry Bulb Temperature for College Station, TX

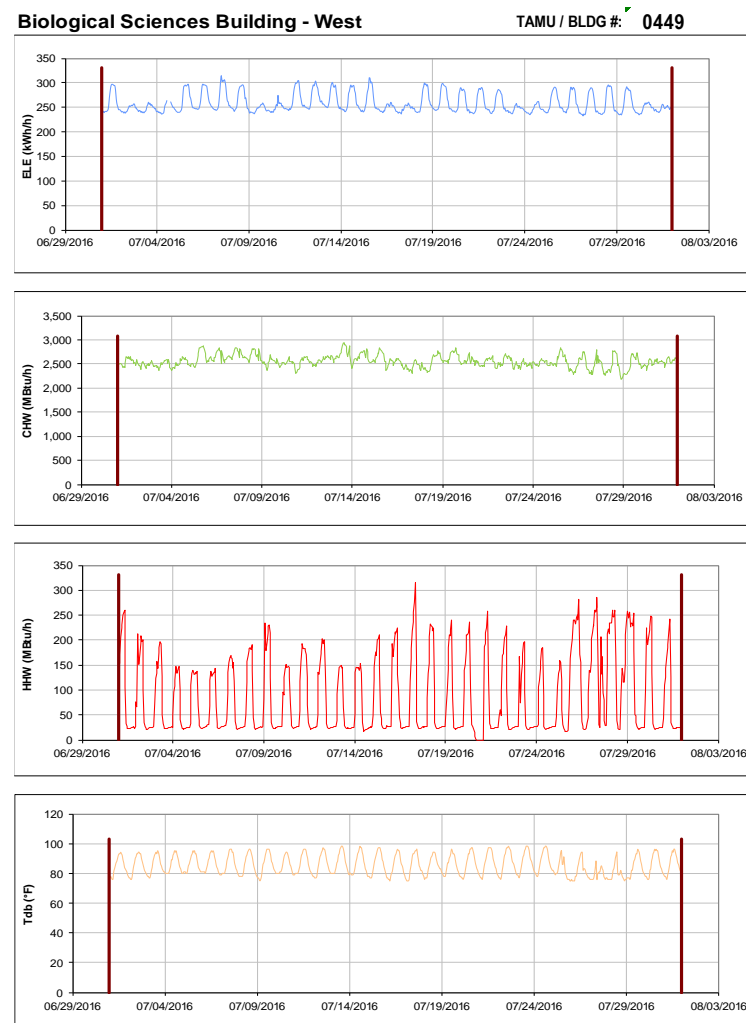
Figure III-64 Hourly Whole Building Electricity, Chilled Water, and Hot Water Consumption for Biological Sciences Building - West during the Month of July 2016 and the Corresponding Hourly Outdoor Dry Bulb Temperature for College Station, TX

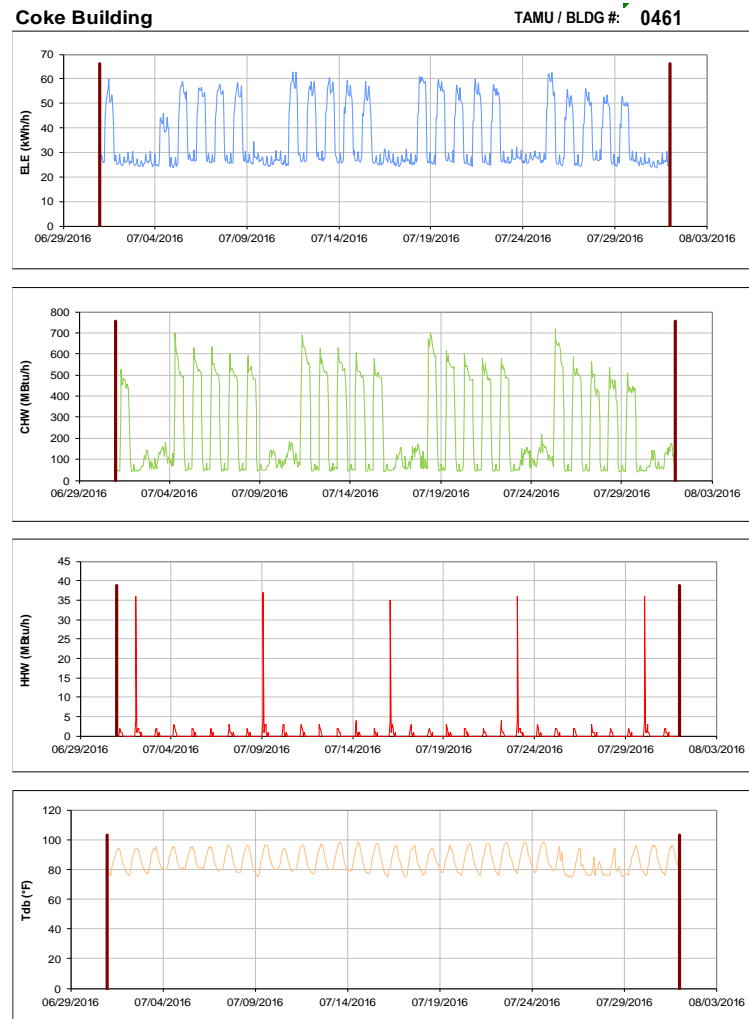
Figure III-69 Hourly Whole Building Electricity, Chilled Water, and Hot Water Consumption for Coke Building during the Month of July 2016 and the Corresponding Hourly Outdoor Dry Bulb Temperature for College Station, TX

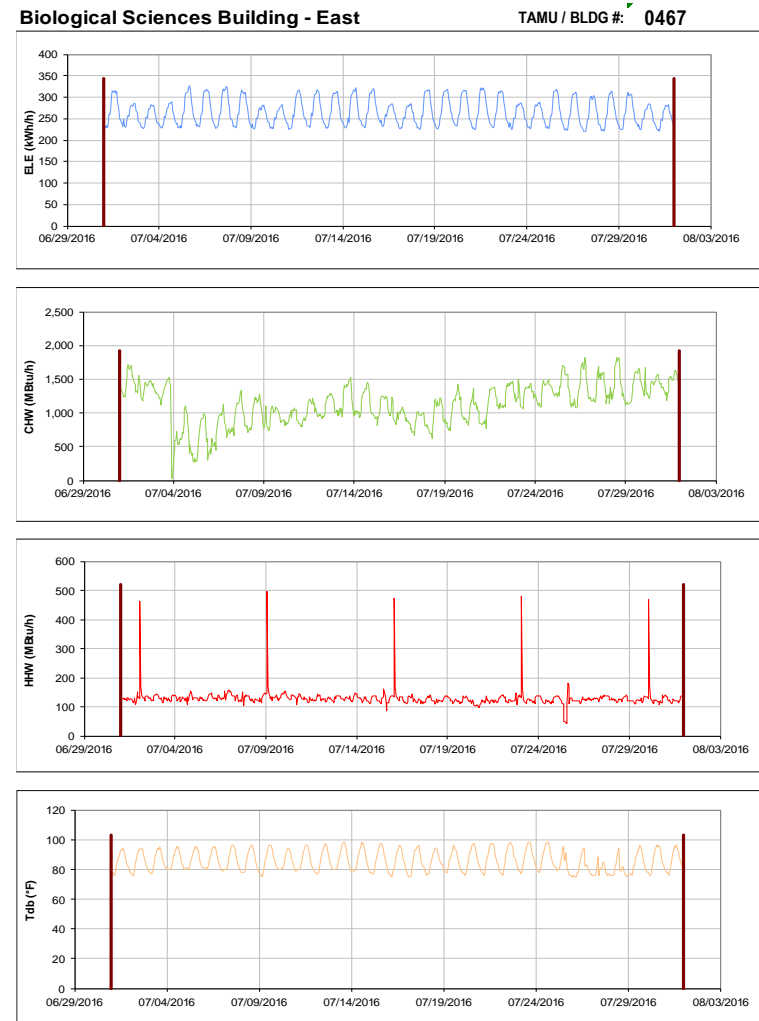
Figure III-74 Hourly Whole Building Electricity, Chilled Water, and Hot Water Consumption for Biological Sciences Building - East during the Month of July 2016 and the Corresponding Hourly Outdoor Dry Bulb Temperature for College Station, TX

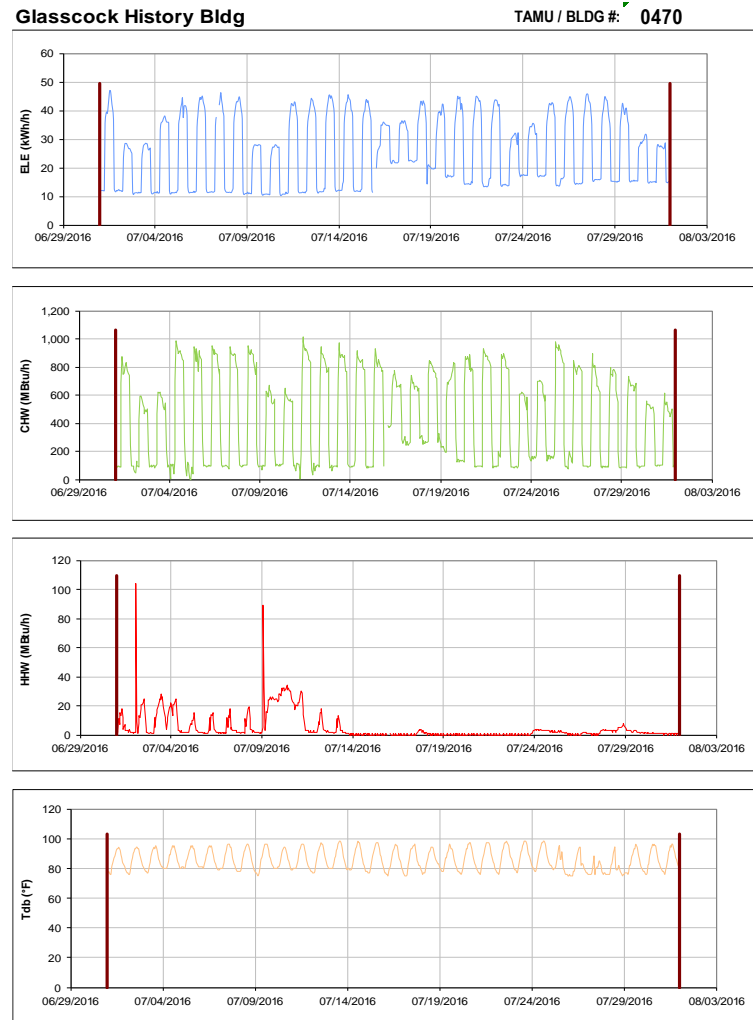
Figure III-77 Hourly Whole Building Electricity, Chilled Water, and Hot Water Consumption for Glasscock History Bldg during the Month of July 2016 and the Corresponding Hourly Outdoor Dry Bulb Temperature for College Station, TX

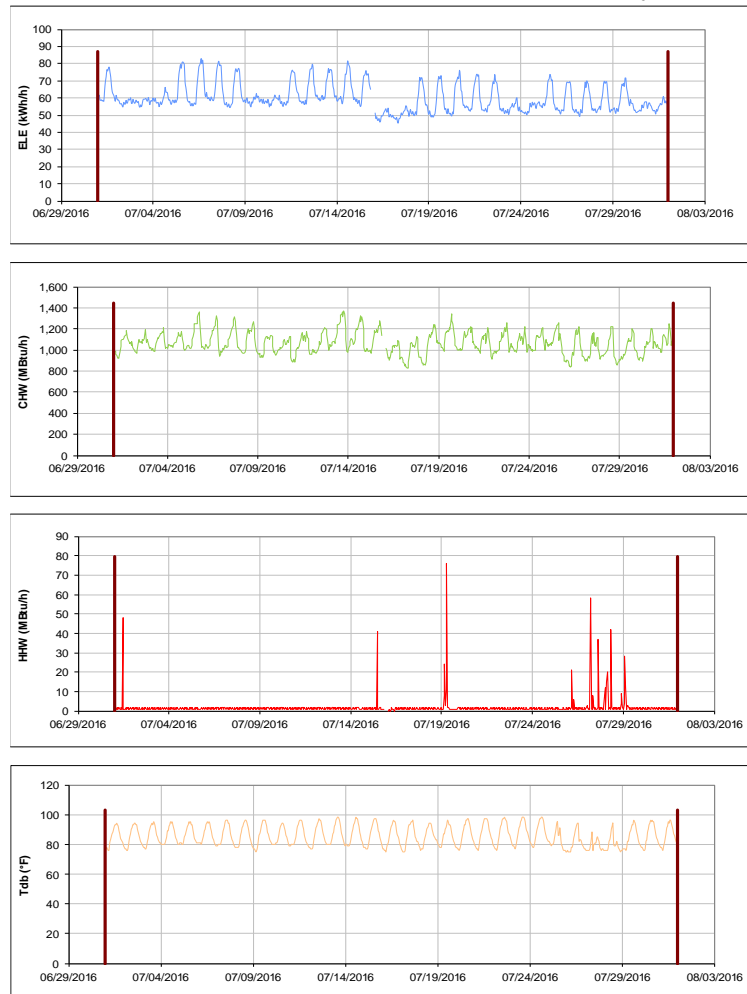
TAMU / BLDG #: 0472

Figure III-79 Hourly Whole Building Electricity, Chilled Water, and Hot Water Consumption for Animal Industries during the Month of July 2016 and the Corresponding Hourly Outdoor Dry Bulb Temperature for College Station, TX

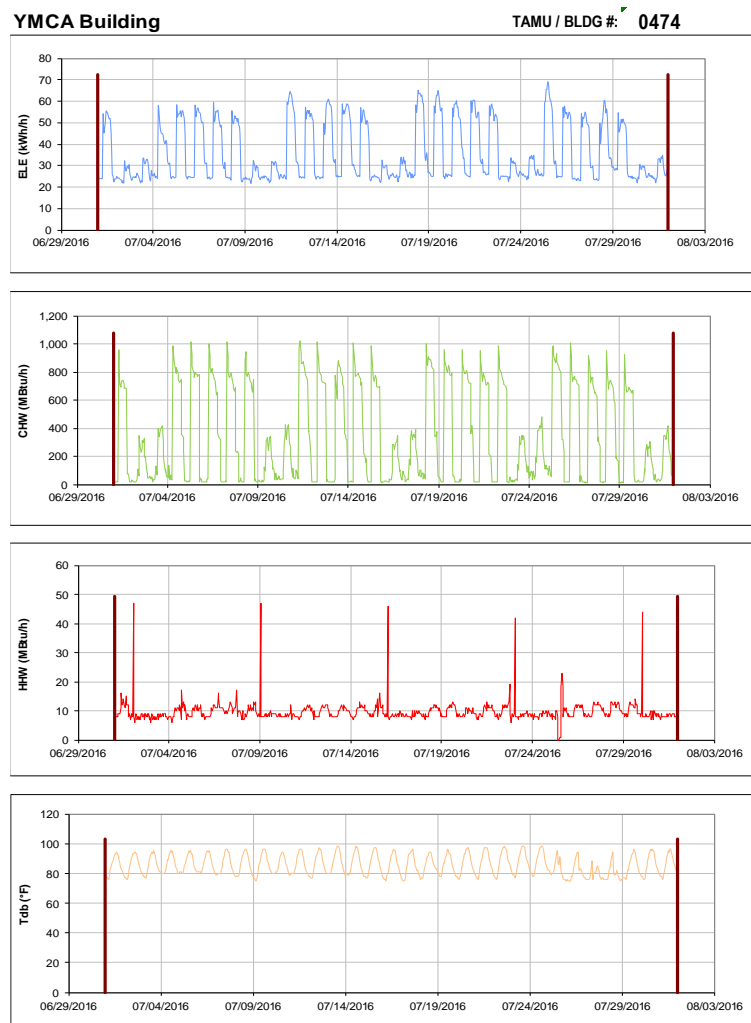
Figure III-81 Hourly Whole Building Electricity, Chilled Water, and Hot Water Consumption for YMCA Building during the Month of July 2016 and the Corresponding Hourly Outdoor Dry Bulb Temperature for College Station, TX

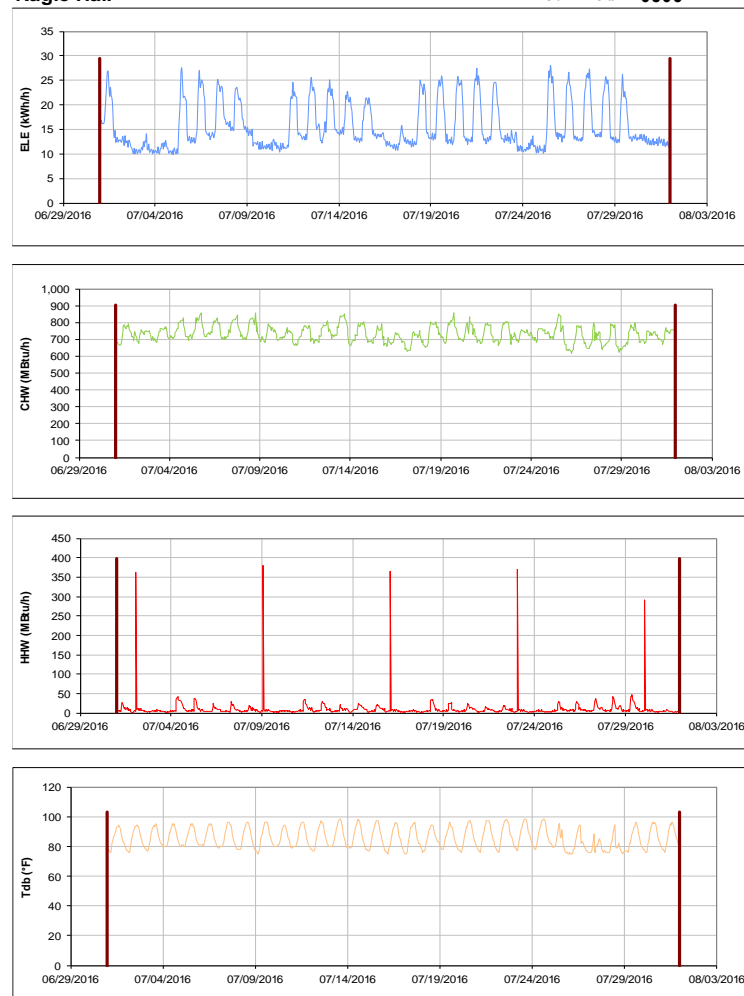
TAMU / BLDG #: 0506

Figure III-96 Hourly Whole Building Electricity, Chilled Water, and Hot Water Consumption for Nagle Hall during the Month of July 2016 and the Corresponding Hourly Outdoor Dry Bulb Temperature for College Station, TX

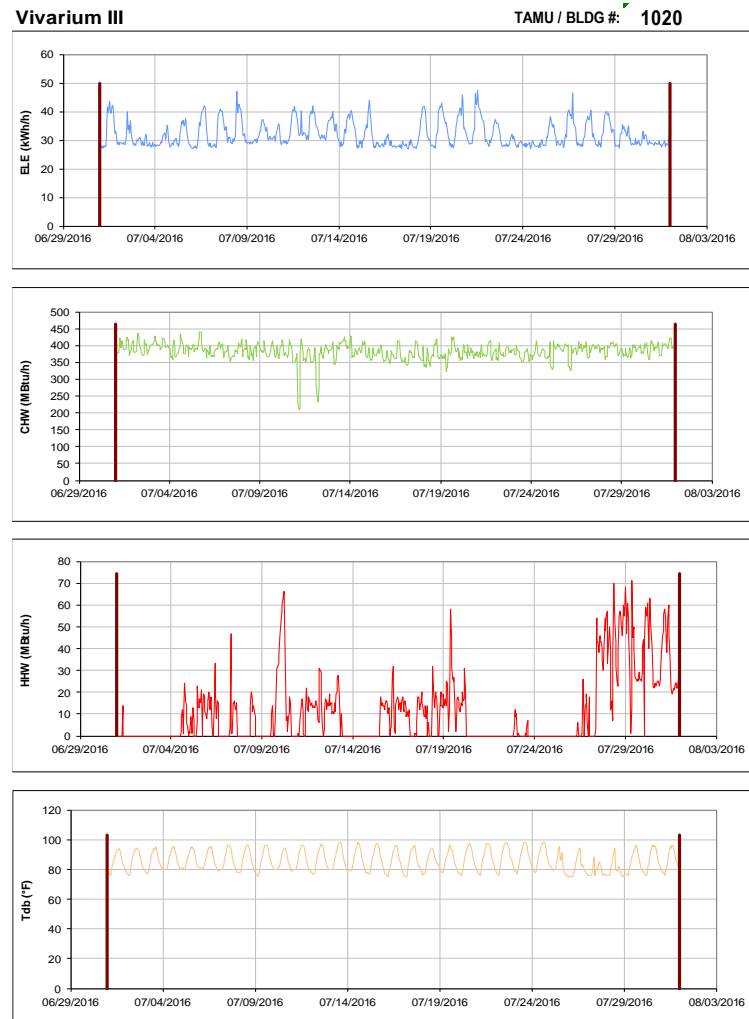
Figure III-119 Hourly Whole Building Electricity, Chilled Water, and Hot Water Consumption for Vivarium III during the Month of July 2016 and the Corresponding Hourly Outdoor Dry Bulb Temperature for College Station, TX

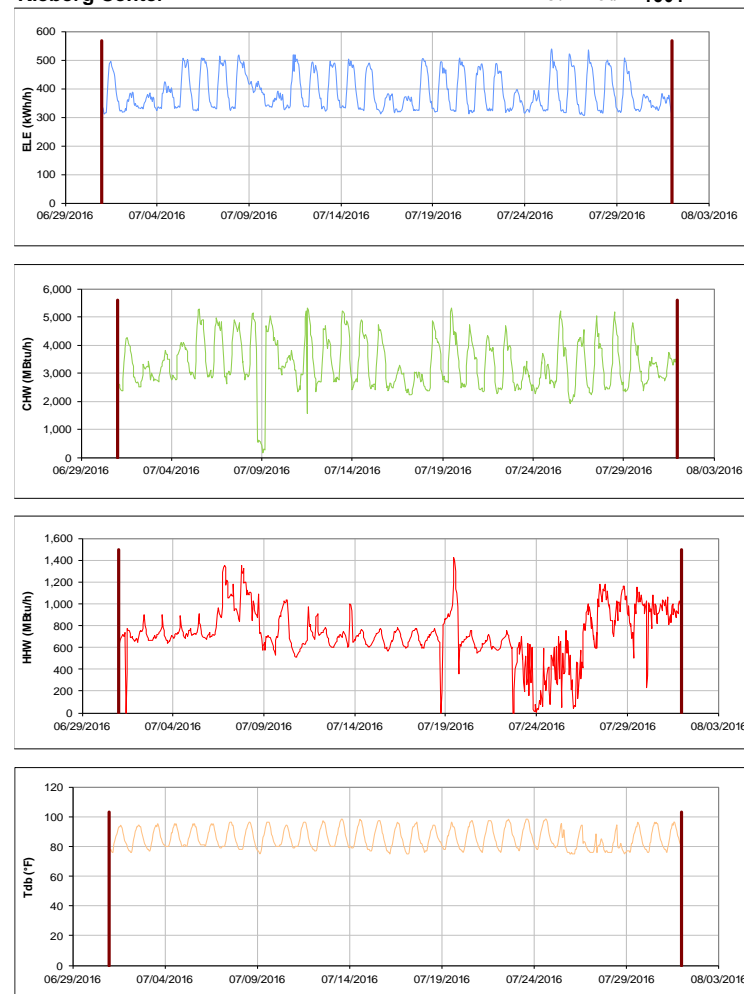
TAMU / BLDG #: 1501

Figure III-144 Hourly Whole Building Electricity, Chilled Water, and Hot Water Consumption for Kleberg Center during the Month of July 2016 and the Corresponding Hourly Outdoor Dry Bulb Temperature for College Station, TX

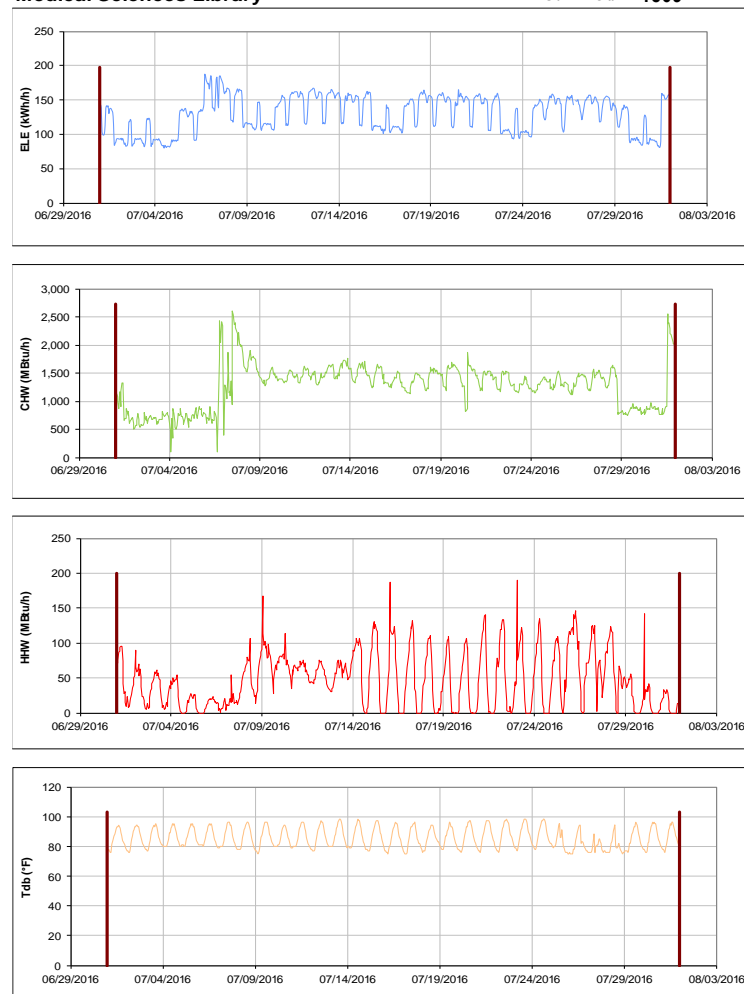
Medical Sciences Library TAMU / BLDG #: 1509

Figure III-152 Hourly Whole Building Electricity, Chilled Water, and Hot Water Consumption for Medical Sciences Library during the Month of July 2016 and the Corresponding Hourly Outdoor Dry Bulb Temperature for College Station, TX

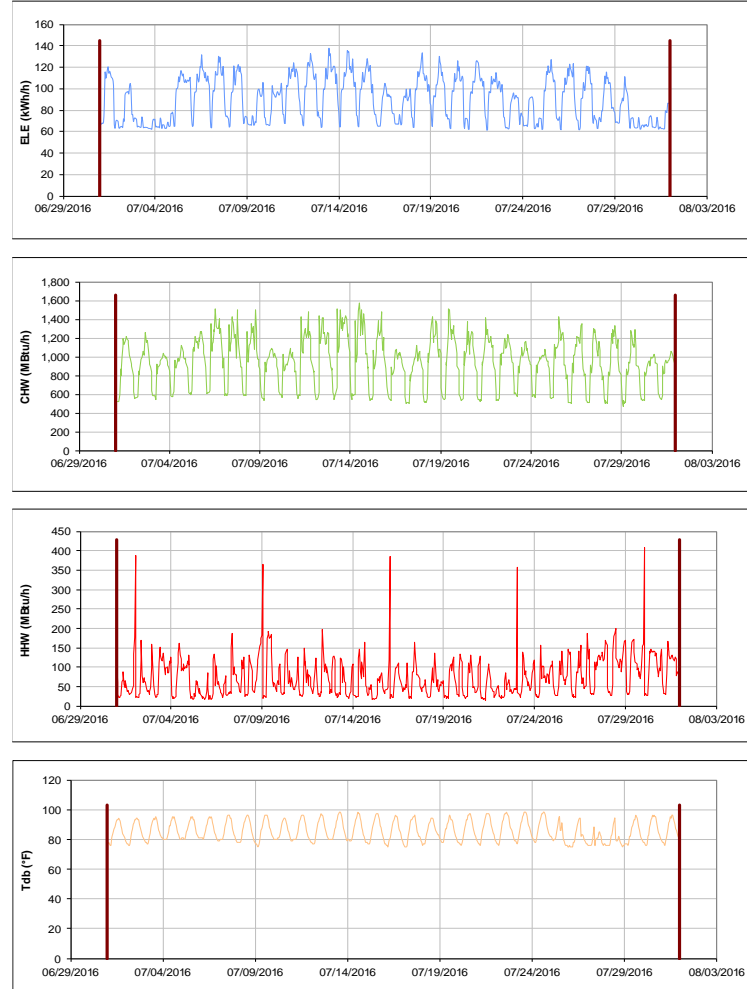
Physical Education Activity Program Building TAMU / BLDG #: 1540

Figure III-163 Hourly Whole Building Electricity, Chilled Water, and Hot Water Consumption for Physical Education Activity Program Building during the Month of July 2016 and the Corresponding Hourly Outdoor Dry Bulb Temperature for College Station, TX

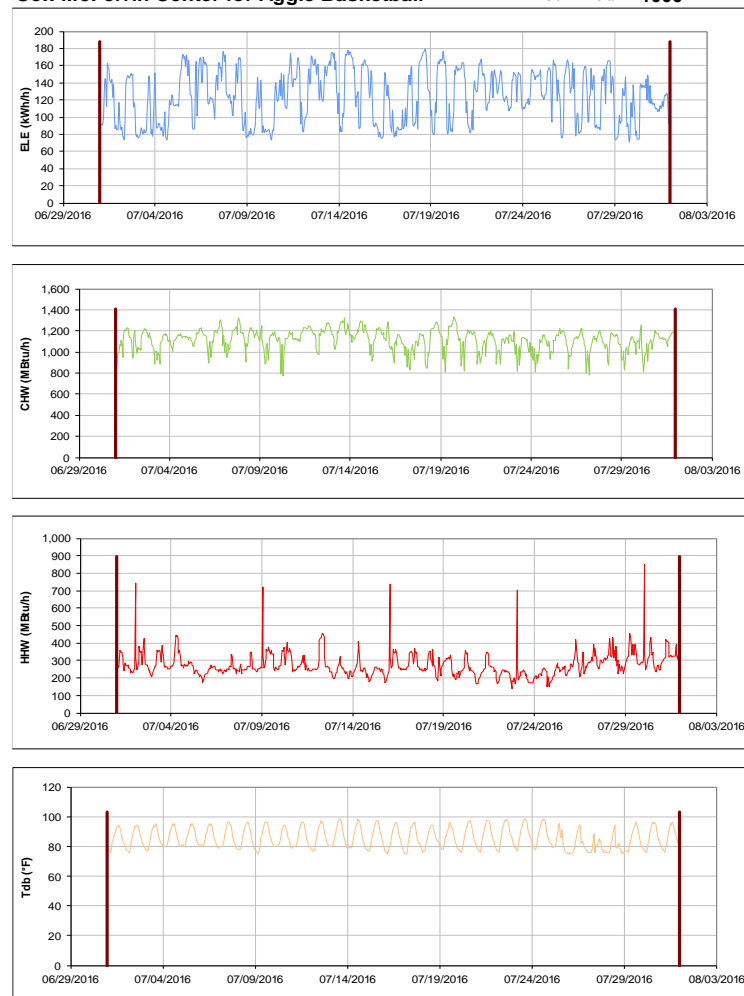
Cox-McFerrin Center for Aggie Basketball TAMU / BLDG #: 1558

Figure III-166 Hourly Whole Building Electricity, Chilled Water, and Hot Water Consumption for Cox-McFerrin Center for Aggie Basketball during the Month of July 2016 and the Corresponding Hourly Outdoor Dry Bulb Temperature for College Station, TX

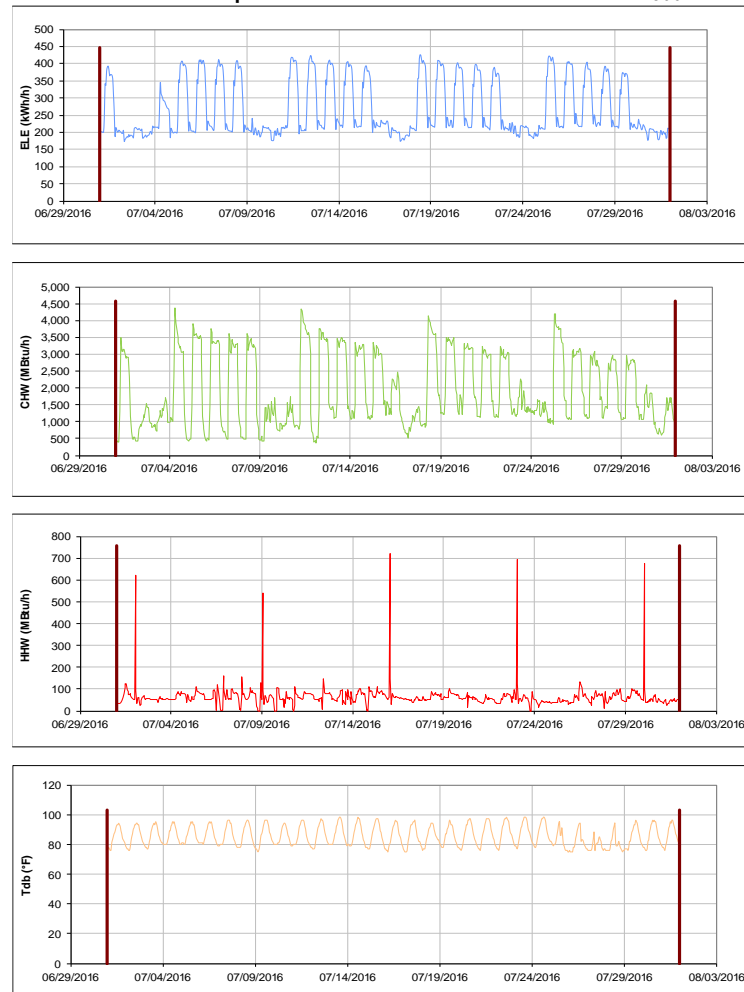
TAMU / BLDG #: 1800

Figure III-180 Hourly Whole Building Electricity, Chilled Water, and Hot Water Consumption for General Services Complex during the Month of July 2016 and the Corresponding Hourly Outdoor Dry Bulb Temperature for College Station, TX

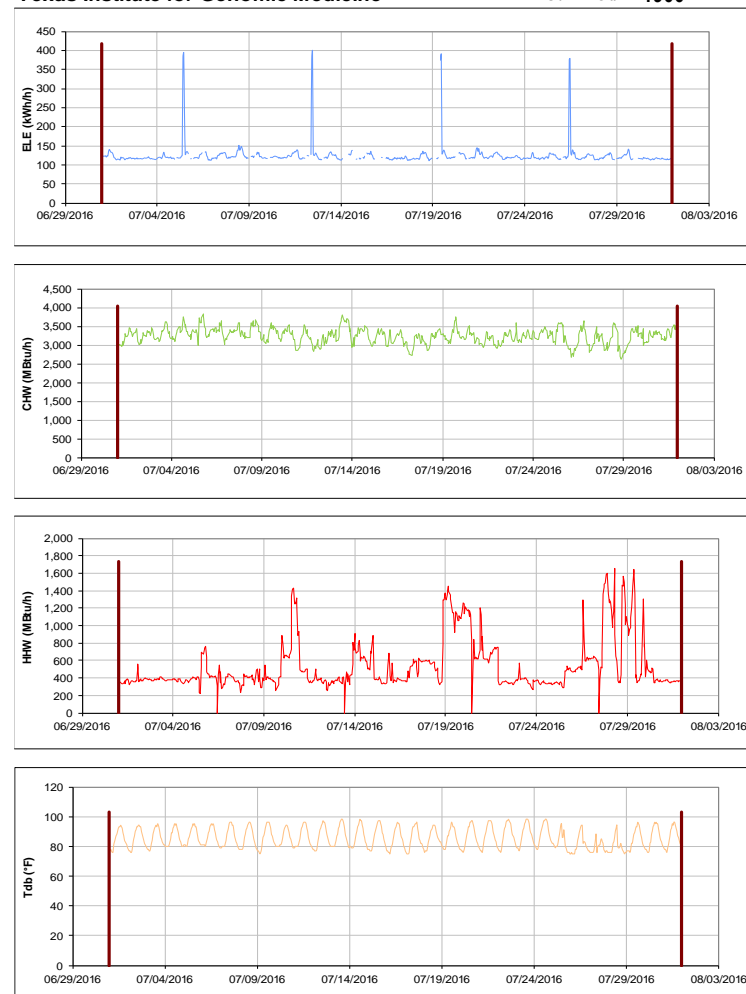
TAMU / BLDG #: 1900

Figure III-184 Hourly Whole Building Electricity, Chilled Water, and Hot Water Consumption for Texas Institute for Genomic Medicine during the Month of July 2016 and the Corresponding Hourly Outdoor Dry Bulb Temperature for College Station, TX
